WILLIAM LEYS DBA
DIVISION 7 WATERPROOFING CONSULTANTS
PO Box 14438 SLO CA 93406 Tel. 805-801-2380
INSPECTIONS/CONSULTING/EXPERT WITNESS

Real Estate Inspection Report on Front Deck
1999 Anywhere Dr Pismo Beach CA
10/29/2015

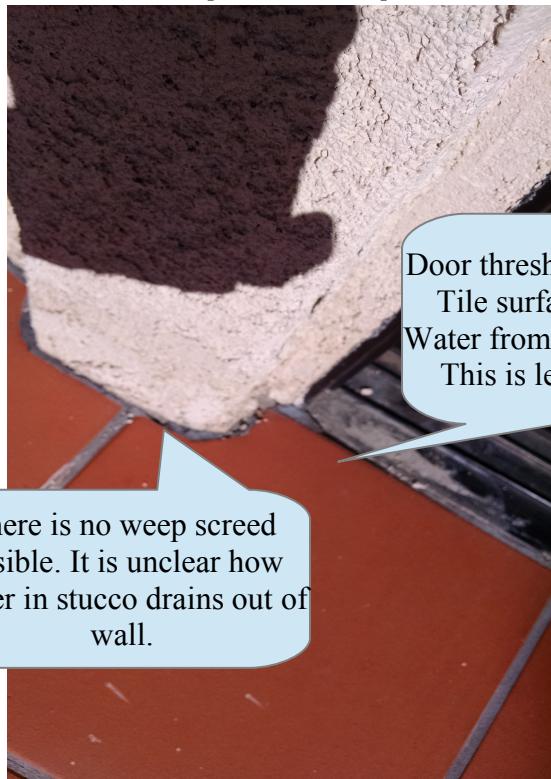
Door/Threshold/Walls

Door threshold is lower than
Tile surface, preventing
Water from draining properly
This is left side of door.

There is a gap between the door and the tile, water may seep under tile as

threshold is lower than tile. Thresholds should be a minimum of 1" above the deck in accordance with building code.

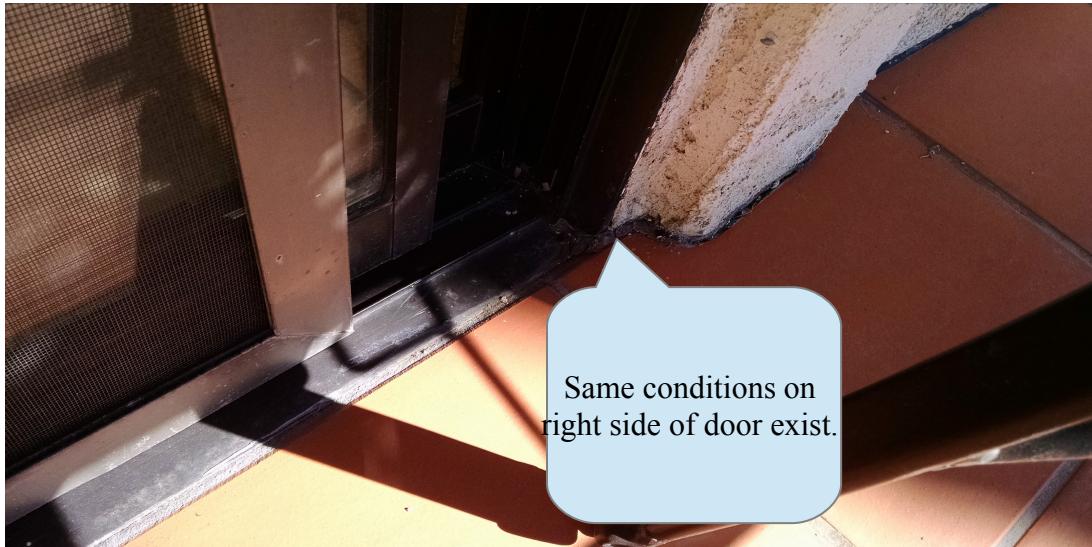
Door threshold remains below height of tile, preventing water from draining.

My second concern is the deck to wall areas where no weep screed/standard termination of the stucco is visible. While older buildings sometimes did not have weep screed, homes of this age generally do. The sliding door threshold is also lower than the tile is especially at each corner. Water may pool in the threshold and leak in.

The adverse conditions described above need to be repaired to ensure that water does not intrude into the interior framing of the deck and home. Because the railing is part of the tiled deck, extensive work may be needed to correct that condition. The door assembly will probably need to be removed and the framing raised to lift the door above the deck height. Both of these actions would disturb the tile work. Because the deck is small, I would recommend that any remedial work include the entire deck to ensure that it is all uniform and ensure it watertightness. Please refer to a licensed decking contractor for bid(s) to repair the adverse conditions found. **END OF REPORT**

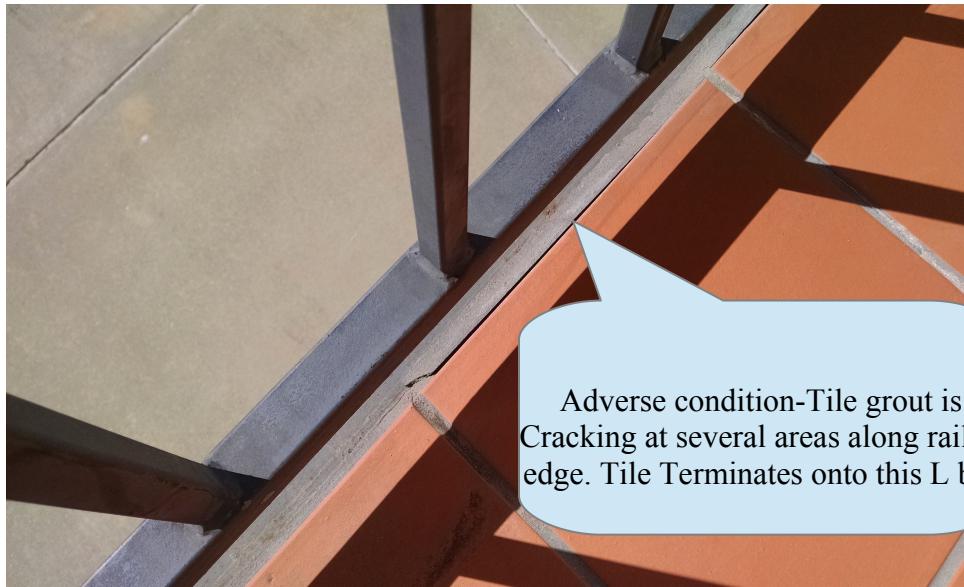
Railing/Edge

The termination of the tile onto part of the railing system is unusual. Typical construction of a deck has the tile and waterproofing system terminating to galvanized flashing that is not part of a railing. See drawing below.

As noted above, the edge termination of this deck is highly unusual and not in keeping with standard industry design. Waterproofing/tile assemblies are typically terminated to a 26 gauge drip edge flashing. In this case, the tile terminates out onto the L bar piece of the railing. In several areas there is rust and degradation on the L bar. No waterproofing was visible at any areas inspected.

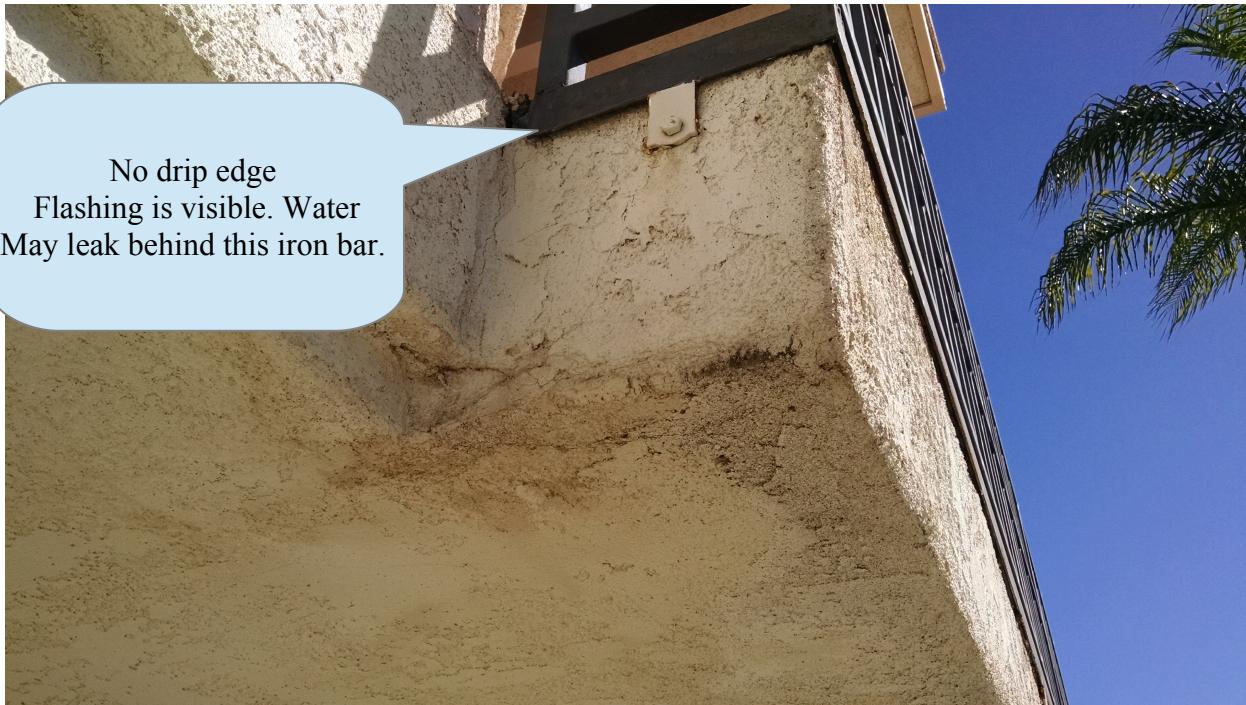
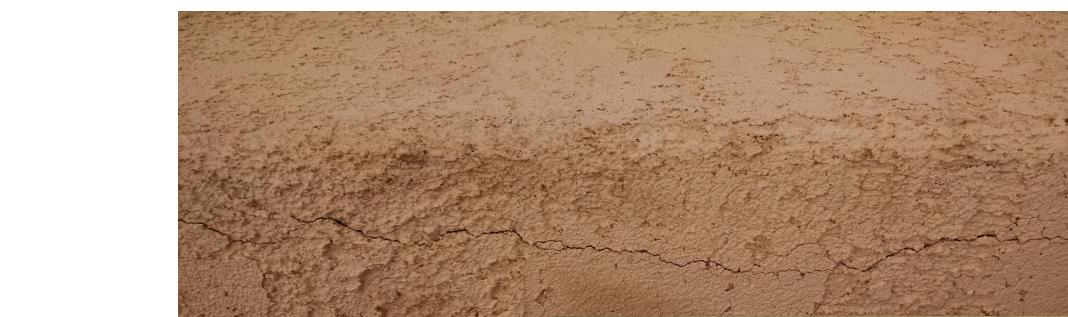
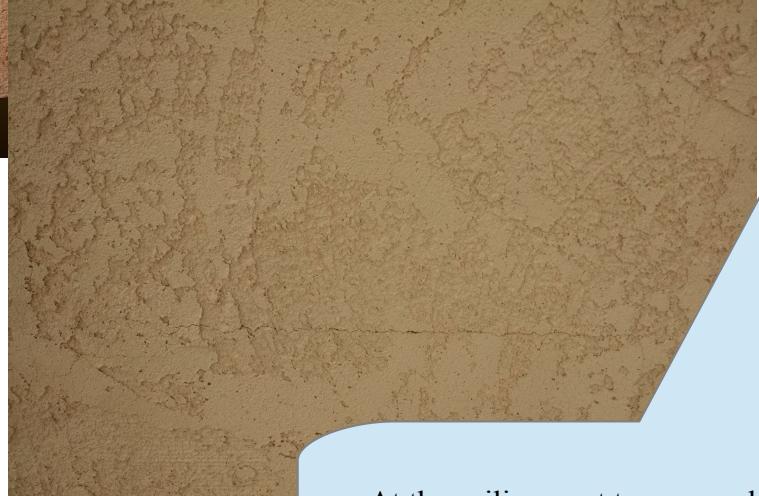
At the ceiling next to garage doors
There are numerous cracks in the stucco.
Some staining is evident from water.

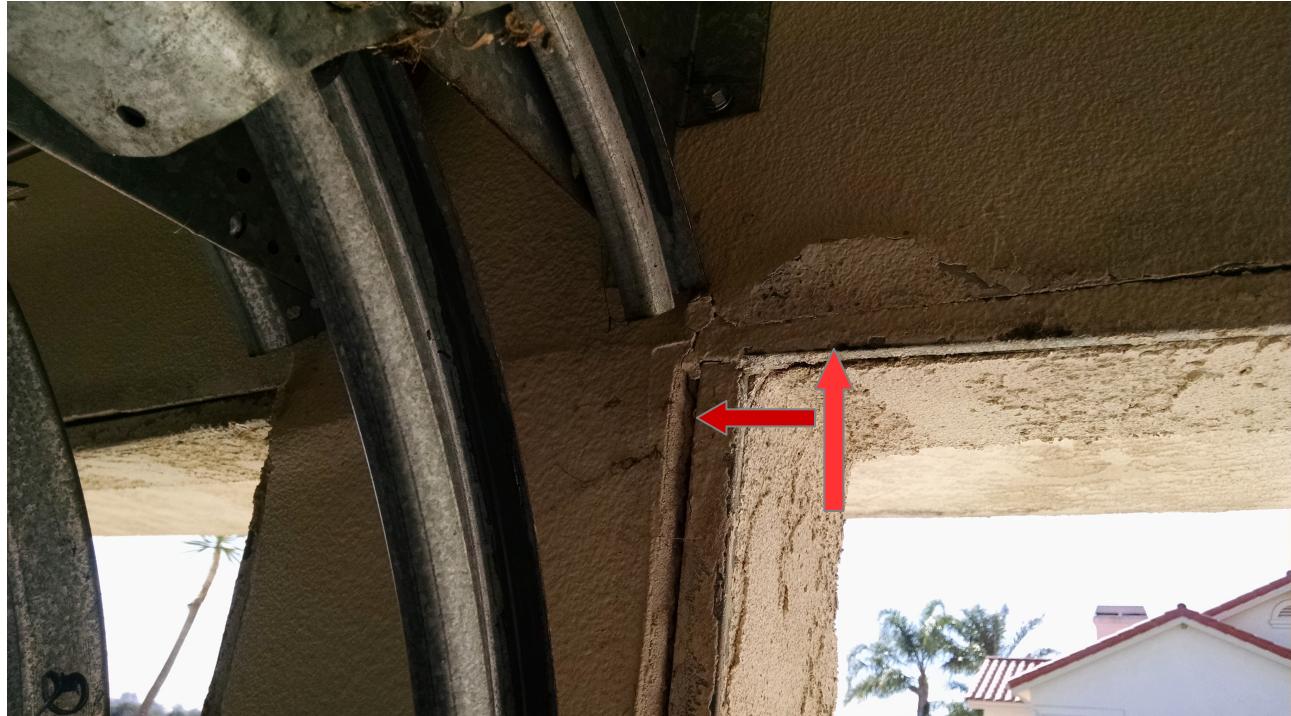
Water may be leaking in from door threshold area directly above. Removal of buckled drywall will provide access to inspect wood behind.
