WILLIAM LEYS DBA
DIVISION 7 WATERPROOFING CONSULTANTS
PO Box 14438 SLO CA 93406 Tel. 805-801-2380
INSPECTIONS/CONSULTING/EXPERT WITNESS

Real Estate Inspection Report on Front Deck
1999 Anywhere Dr Pismo Beach CA
10/29/2015

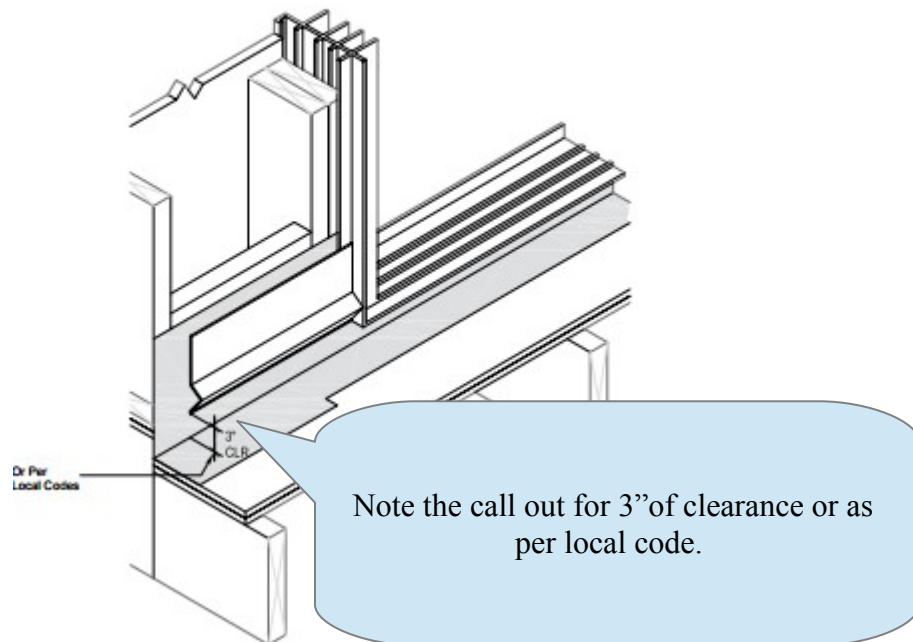
Sample Detail of Deck To Wall Waterproofing and Stucco Assembly

Door threshold remains below height of tile, preventing water from draining.

My second concern is the deck to wall areas where no weep screed/standard termination of the stucco is visible. While older buildings sometimes did not have weep screed, homes of this age generally do. The sliding door threshold is also lower than the tile is especially at each corner. Water may pool in the threshold and leak in.

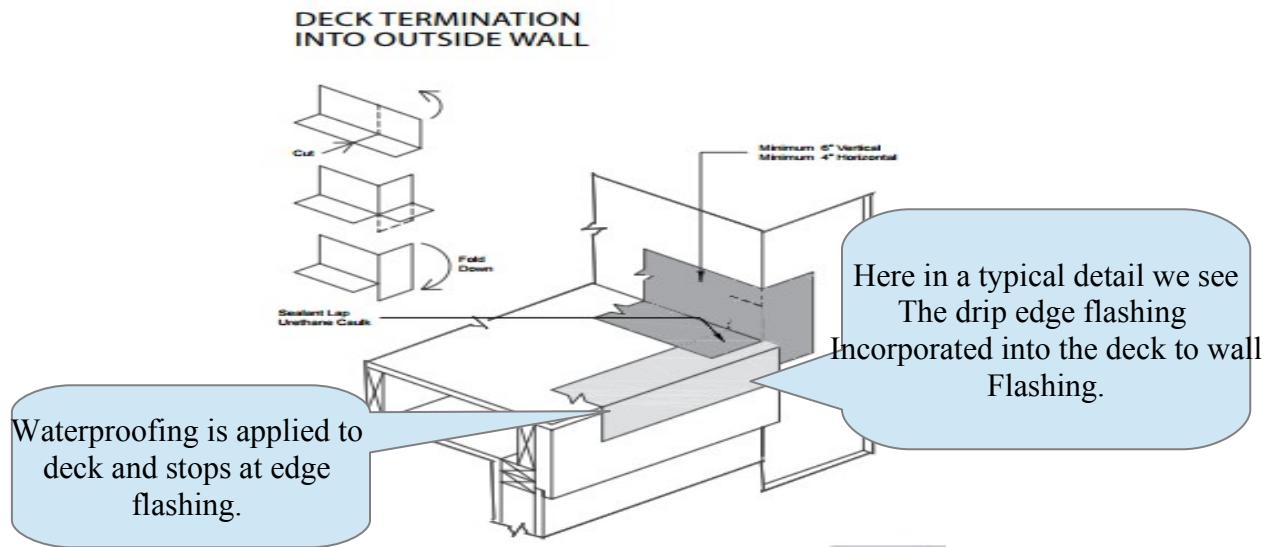
The termination of the tile onto part of the railing system is unusual. Typical construction of a deck has the tile and waterproofing system terminating to galvanized flashing that is not part of a railing. See drawing below.

As noted above, the edge termination of this deck is highly unusual and not in keeping with standard industry design. Waterproofing/tile assemblies are typically terminated to a 26 gauge drip edge flashing. In this case, the tile terminates out onto the L bar piece of the railing. In several areas there is rust and degradation on the L bar. No waterproofing was visible at any areas inspected.

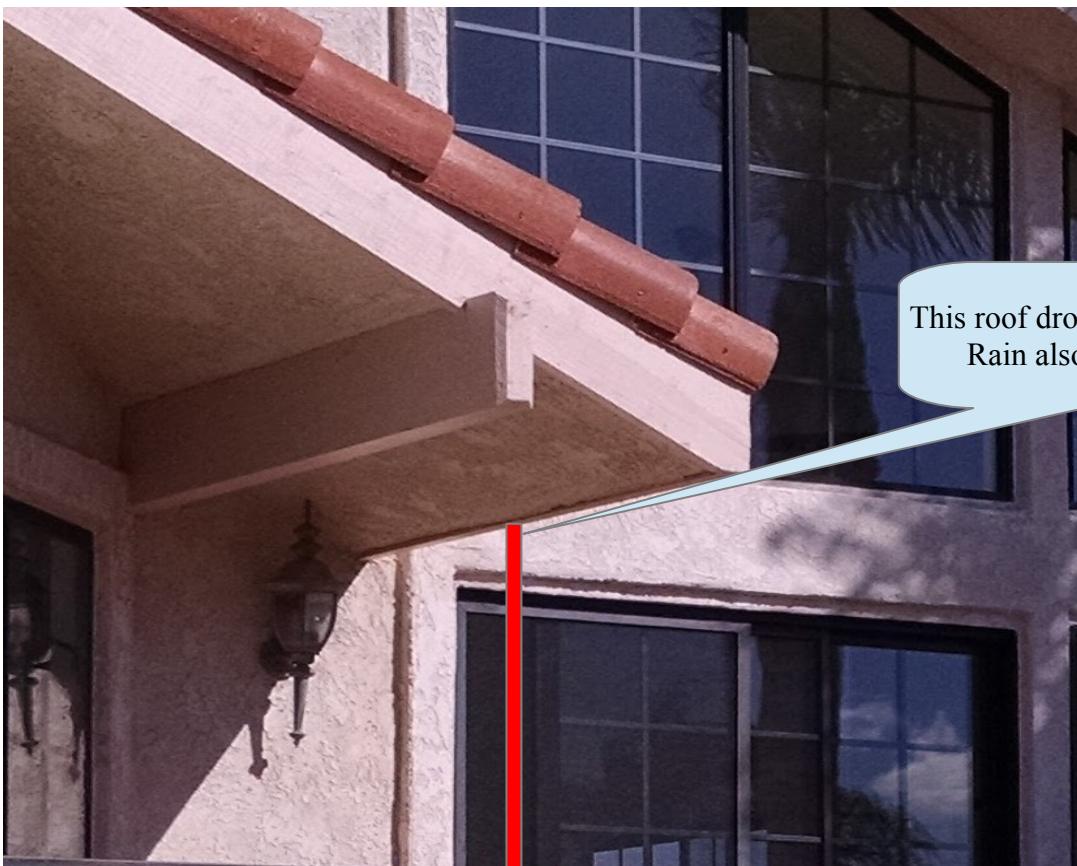
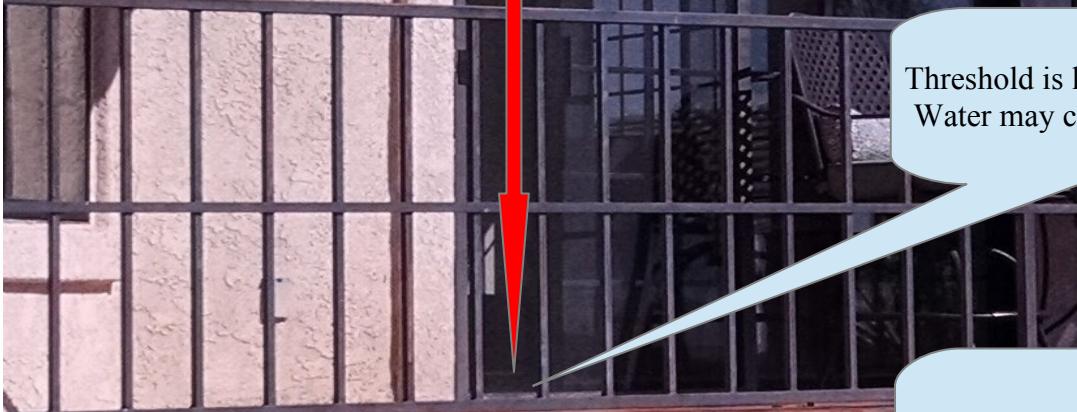
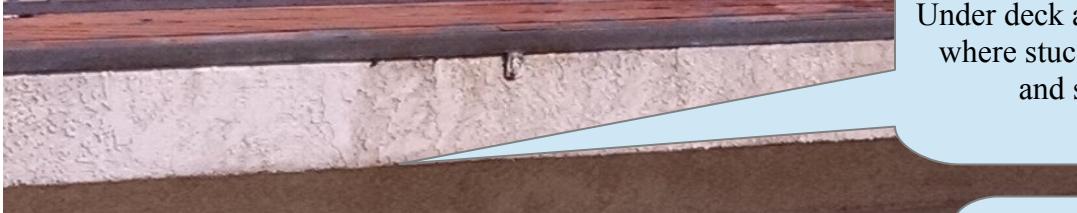
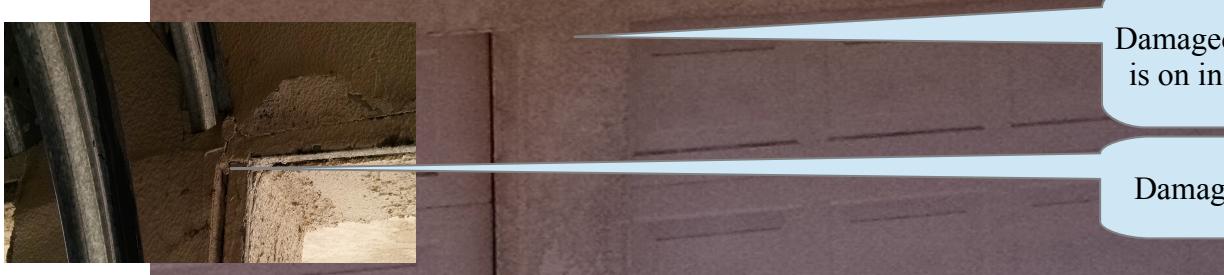
Water may be leaking in from door threshold area directly above. Removal of buckled drywall will provide access to inspect wood behind.
